# FUSION Assessment 2019

FUSION Assessment – 2019  
Rio Hondo Community College District

## Executive Summary Report

# RIO HONDO COLLEGE

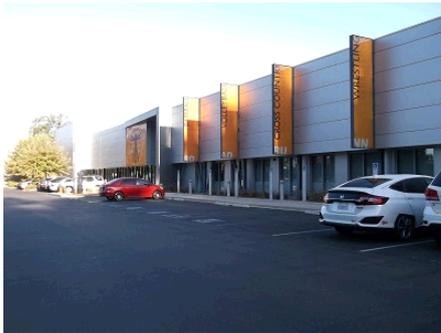
**Facility:** \Rio Hondo\Rio Hondo College\0003 GYMNASIUM

The roof on the Gym and Wrestling buildings are built-up type, last replaced in 1997, per staff and coated single-ply rolled asphalt of 2013 vintage. The gym roof was treated with a poly coating that is blistering.

Roofing on Gym and Wrestling Cntr needs to be replaced.

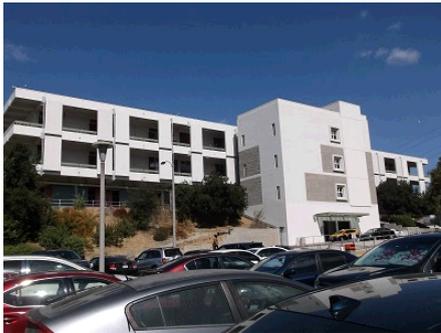
Facility: \Rio Hondo\Rio Hondo College\0006 SCIENCE

- 1 First floor mechanical room has water damage to the interior wall.
- 2 Water fountains at first floor restroom damaged.
- 3 First floor men's restroom gang sink out of service
- 4 Roof needs a resurfacing
- 5 Roof top exterior door to stairwell damaged in need of replacement

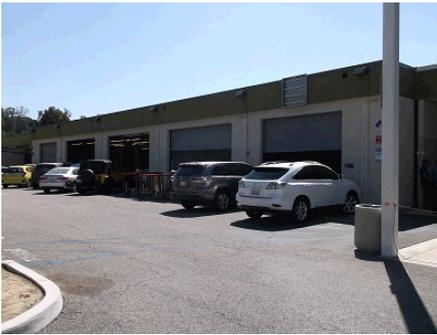
**Facility:** \Rio Hondo\Rio Hondo College\0007 APPLIED TECHNOLOGY

1 roofing is showing signs of patch repairs needed

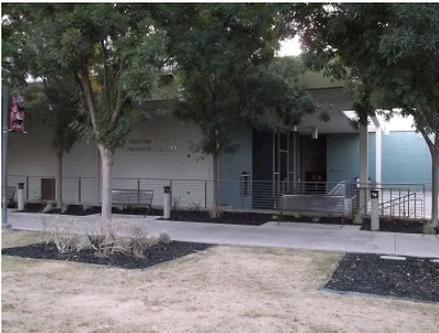
**Facility:** \Rio Hondo\Rio Hondo College\0008 MUSIC

- 1 Water damage to wall in restroom.
- 2 The water fountain is broken.
3. Palm tree branches laying on the roof

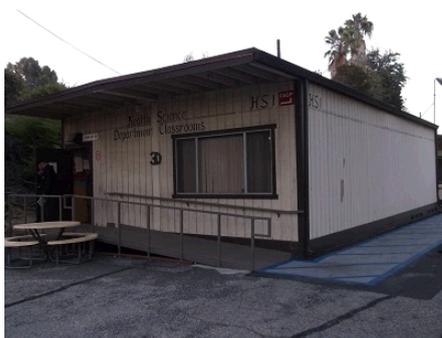
Facility: \Rio Hondo\Rio Hondo College\0019 HEALTH SCIENCE 1

- 1 exterior T111 siding water damage
- 2 paint peeling from building
