# FUSION Assessment 2019

FUSION Assessment – 2019  
Rio Hondo Community College District

## Executive Summary Report

# RIO HONDO COLLEGE

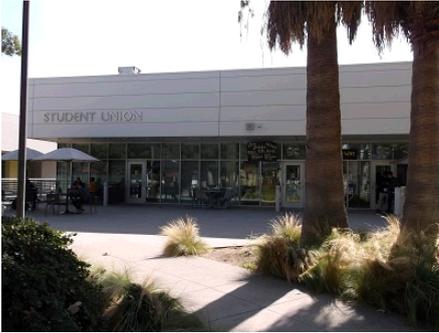
Facility: \Rio Hondo\Rio Hondo College\0127 STUDENT UNION

1 Room SU001 Mechanical Closet has some type of a leaking substance that is creating deterioration of the materials in the space attention is need for this room before irreversible damage is done.
