**Rio Hondo Community College District
Contract Management and Vending Services
3600 Workman Mill Road, A-103
Whittier, CA 90601-1699**

**February 14, 2023
Addendum No. 4
Bid No. 2090: Re-Roofing of Science Building Project**

RHC - SCIENCE BUILDING NEW ROOF

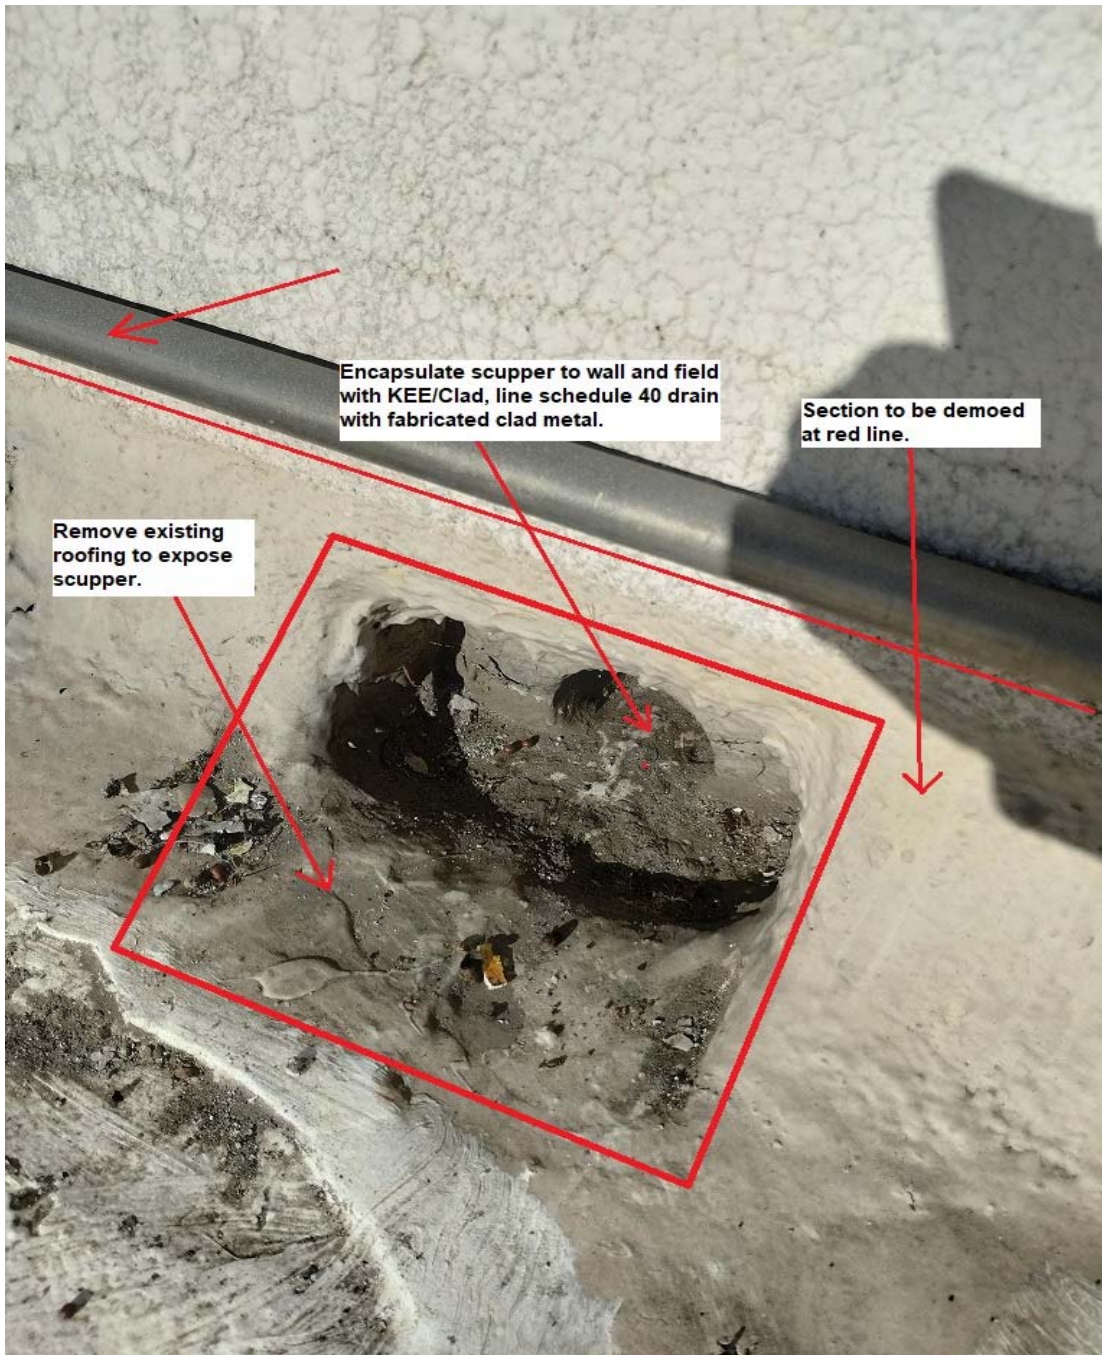
A. Existing scuppers shall be overlaid with fabricated 24 ga pvc clad metal as specified and called out in the addendum. Scuppers shall remain and be encapsulated with new fabricated 24 ga pvc clad metal. Clad piece shall be flashed onto walls and inserted into schedule 40 pipe on exit. Owner will remove the existing electrical conduit and relocate to field.

13. See the attached Roof Plan and Supper photograph for more Scope of Work requirements.

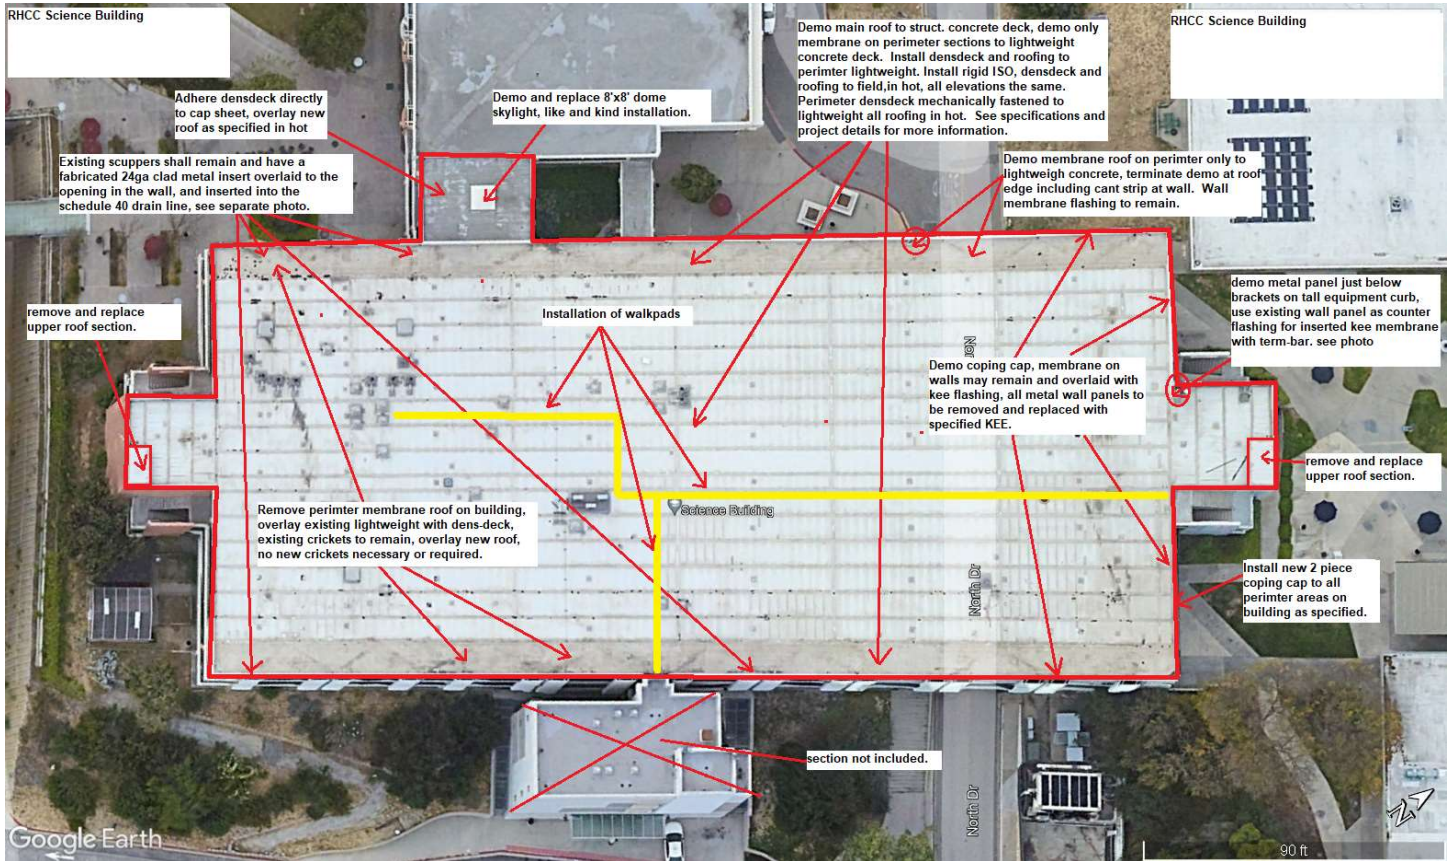
Owner to relocate electrical conduit to field of roof from existing wall location.

Section to be demoed at red line.

Remove existing roofing to expose scupper.

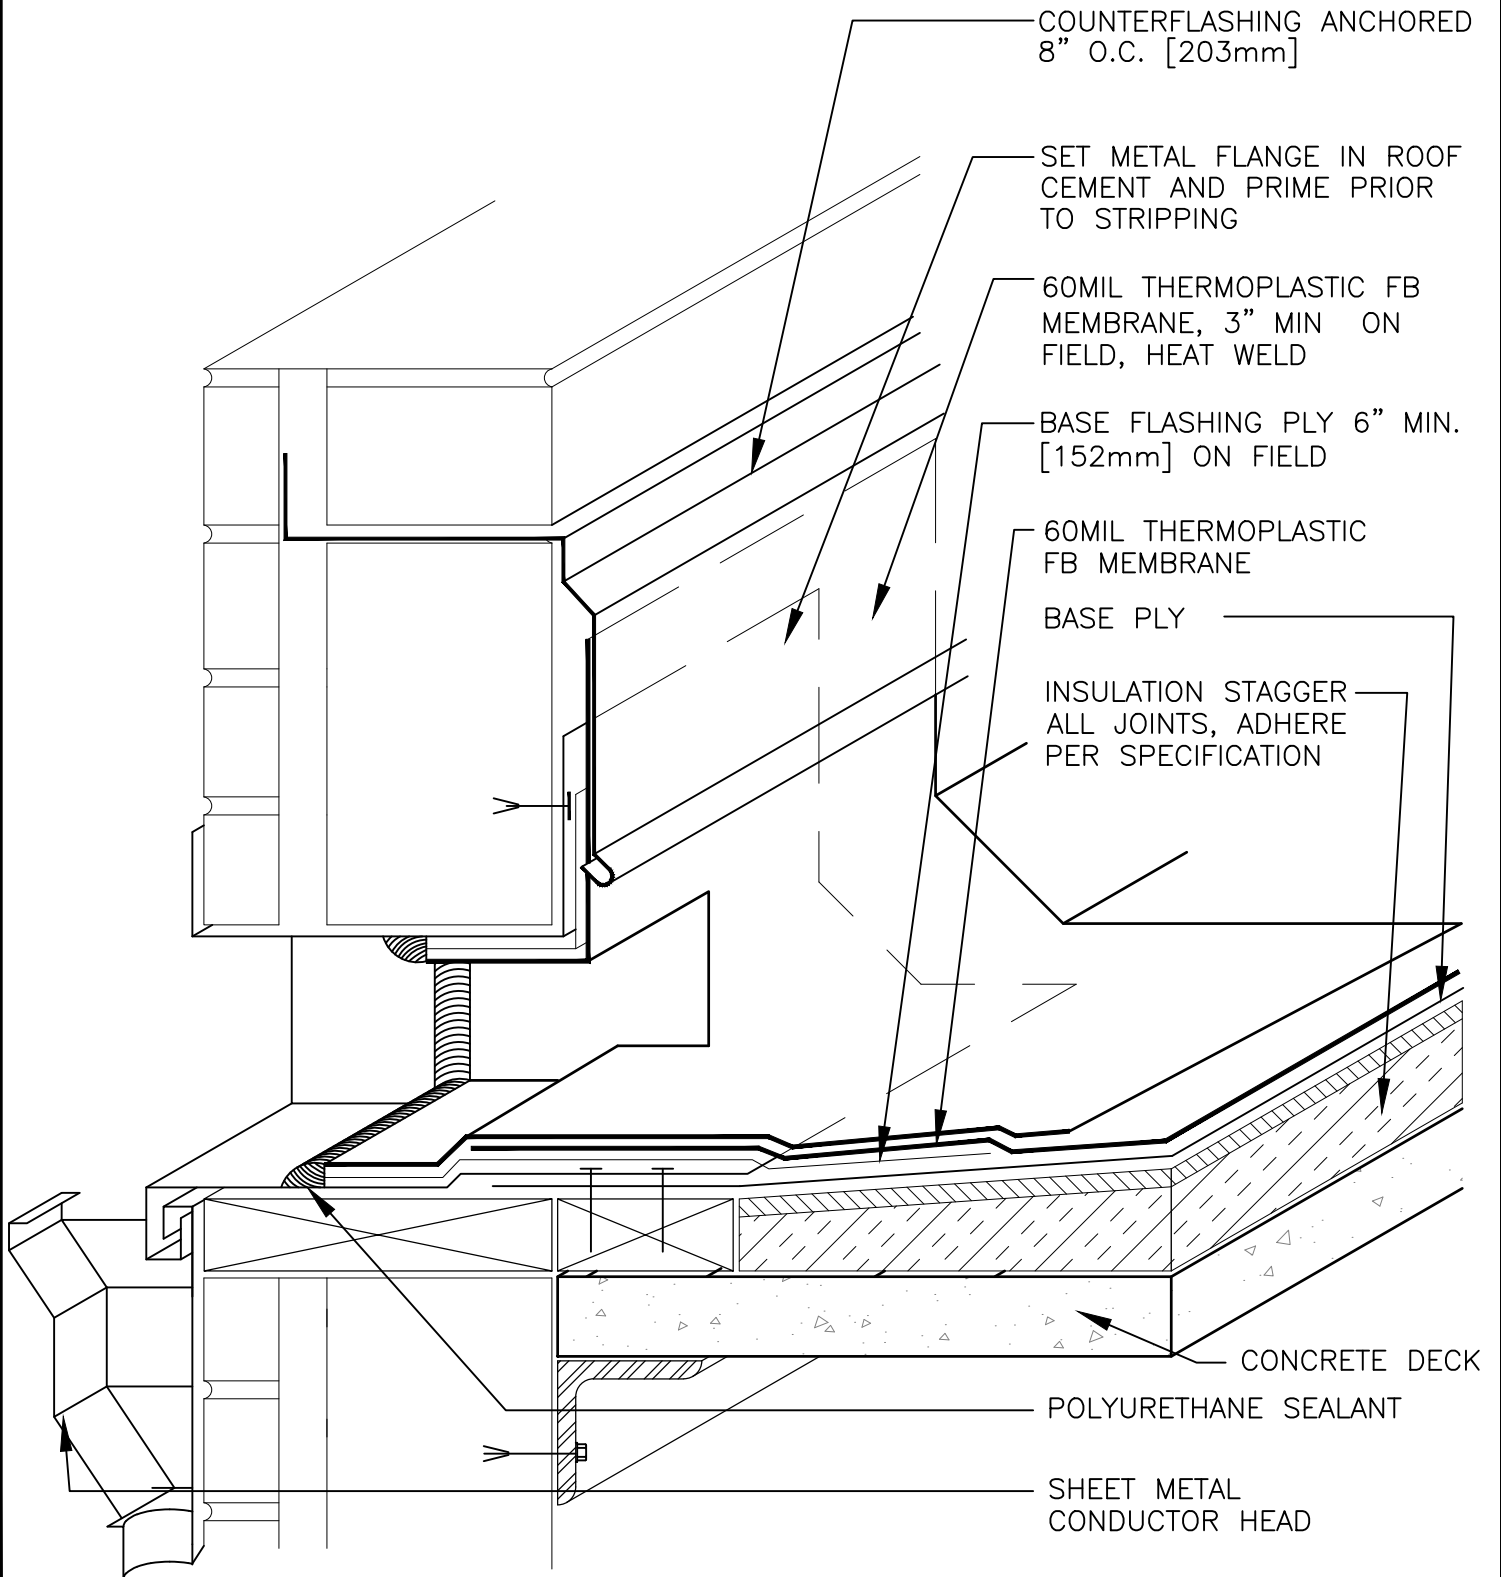
ALL PLIES SET IN BITUMEN SEE
SPECIFICATIONS FOR SURFACING
